Contract #: 04-0120F4Cty: SF/ALA Rte: 80 PM: 13.2/13.9File #: 1.28**WELDING INSPECTION REPORT****Resident Engineer:** Casey, William**Address:** 333 Burma Road**City:** Oakland, CA 94607**Report No:** WIR-030068**Date Inspected:** 24-Sep-2013**Project Name:** SAS Superstructure**OSM Arrival Time:** 700**Prime Contractor:** American Bridge/Fluor Enterprises, a JV**OSM Departure Time:** 1730**Contractor:** American Bridge/Fluor Enterprises, a JV**Location:** Job Site**CWI Name:** Bernie Docena**CWI Present:** Yes No**Inspected CWI report:** Yes No N/A**Rod Oven in Use:** Yes No N/A**Electrode to specification:** Yes No N/A**Weld Procedures Followed:** Yes No N/A**Qualified Welders:** Yes No N/A**Verified Joint Fit-up:** Yes No N/A**Approved Drawings:** Yes No N/A**Approved WPS:** Yes No N/A**Delayed / Cancelled:** Yes No N/A**Bridge No:** 34-0006**Component:** SAS Tower**Summary of Items Observed:**

WELDING INSPECTION REPORT

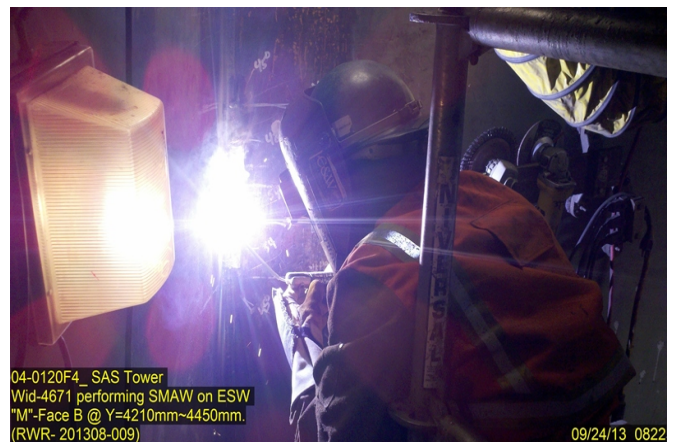
The QA Inspector observed ABF welder Mike Jimenez (WID-4671) performing Shield Metal Arc Welding (SMAW) on the repair excavation of Electroslag Weld (ESW) "M" Face B @ Original Y-4400mm. Location of the repair is as follows:

Repair excavation (Y=-4210mm~4450mm) L=340mm, W=47mm, D=54mm.

Prior to welding, Mr. Jimenez was observed preheating the weld to over 300° Fahrenheit using the Miller ProHeat 35 with heat induction blankets and a propylene torch. The QA Inspector observed Mr. Jimenez using a temperature indicator to check the preheat. The welder was using 4.0mm diameter electrode (E7018-1 HR4) per ABF Welding Procedure Specification (WPS) ABF-WPS-D15-1000-Repair Rev.3. The welding process in use was the SMAW process. ABF QC Inspector Bernie Docena performed welding parameters verifications at random intervals throughout the shift and informed the QA Inspector that the average welding amps were at -180. On this date the weld repair at this location was completed and Mr. Jimenez was observed grinding the weld reinforcement and applying the postheat with Miller Proheat 35 as instructed per RWR-201308-009. Mr. Jimenez will continue with repairs on ESW "M" on 9-25-13. The welding observed appeared to be in compliance with the WPS noted above.
